INVENTORY FORM FOR STATE HISTORIC SITES SURVEY

1018 S. Charles St.

HISTORIC PRESERVATION CERTIFICATION APPLICATION
PART 1 - EVALUATION OF SIGNIFICANCE

1. Name of property: 1018 South Charles Street
Address of property: 1018 South Charles Street
City Baltimore County _____ State MD Zip Code 21230
Name of historic district: Federal Hill Historic District

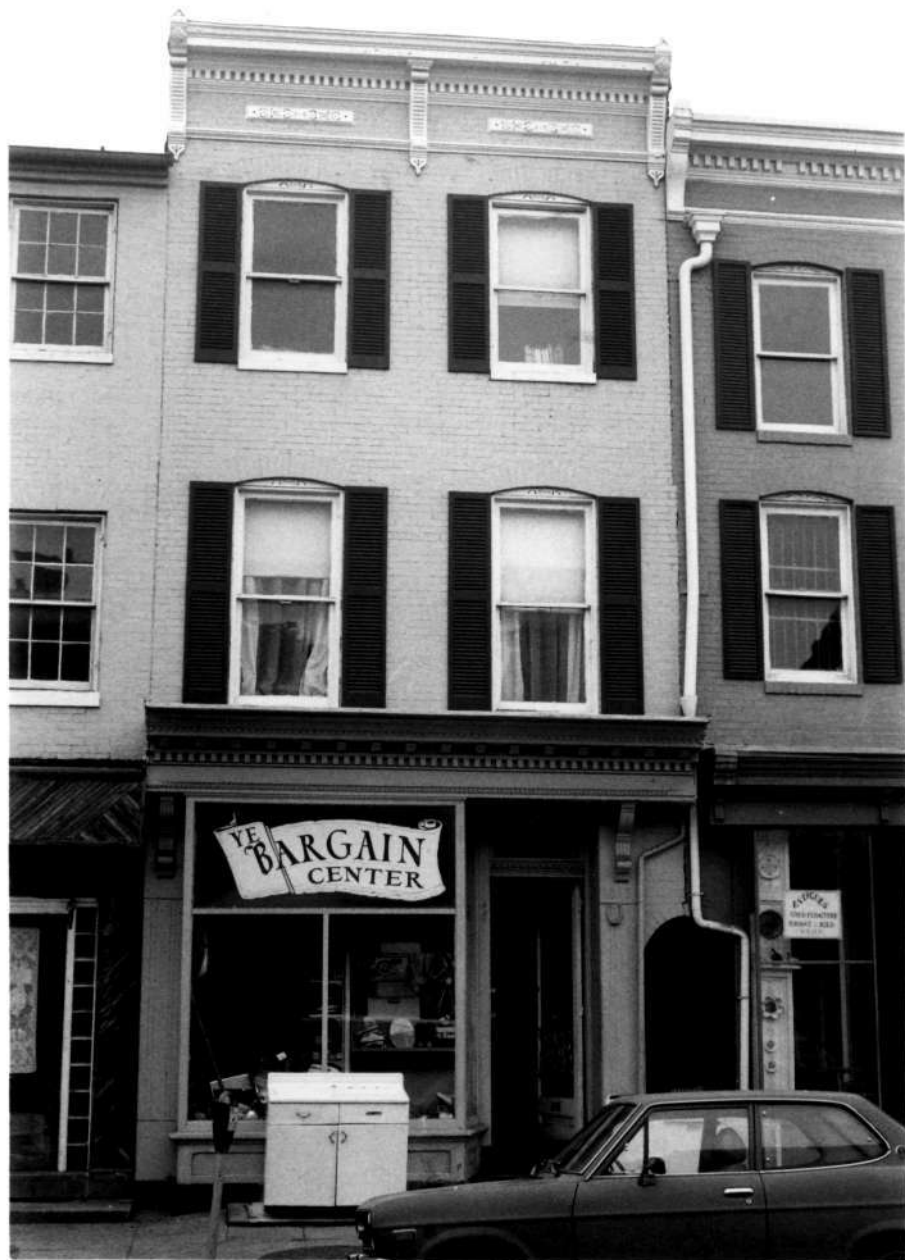
East elevation

This three story, two bay brick house with shed roof and bracketed cornice represents a remodeling of the original gable roofed house that was built on this site in the 1840's and formed part of a row of such houses extending along this side of Charles St. The first floor area of the house has been converted into a store-front.

The house is three stories in height, 15' wide, and occupies a lot 84' deep. The house is constructed in running bond. The shed roof is capped by a stamped sheet metal cornice consisting of a deeply projecting crown molding set above a row of dentils and a molding strip. Three brackets connect the cornice to a lower molding strip, the two end brackets terminating at their upper edges in "anthemion" motifs. Two punched metal ventilating panels punctuate the brick frieze formed between the cornice and the lower molding strip.

The second and third floor window openings have segmentally arched brick lintels with scroll-sawed tympanums. The sills are wood. All of the window openings are filled with 1/1 double hung sash. The first floor area has been converted into a store-front. A glass and panel door, set beneath a single light transom, the lower edge of which is bordered by a row of quarter-round carvings and a row of dentils, is located in the northernmost bay, flanked by a three-sided plate glass shop window set on a paneled wooden base. The front of the shop window has two lower vertical panels of glass set beneath an upper horizontal panel of glass. The entire store-front area has a deep wooden cornice, consisting of a deeply projecting crown molding decorated with a row of pointed scallops and set above a row of modillions, a row of dentils, and a deep frieze area bordered by a row of cut-work scallops. Two grooved end brackets support the cornice. The entrance is reached by two stone steps. An arched alleyway runs back between 1018 and 1016 Charles St.
